3D Interior Measurement The acoustic camera as solution for a full-vehicle NVH ANALYSIS IN AN AIRCRAFT

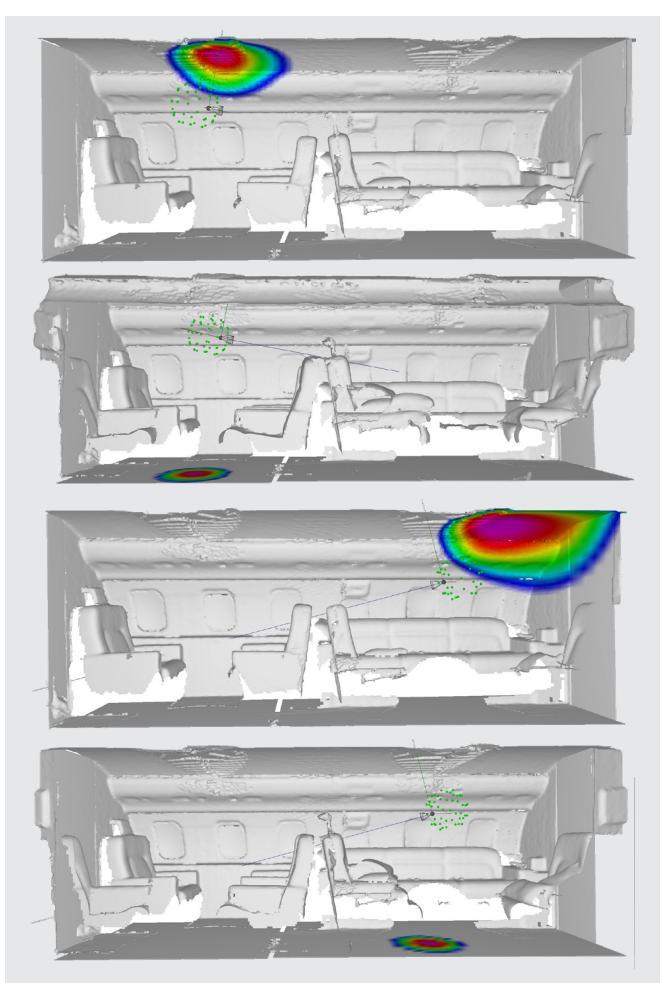
Fig. 2 Time domain results for the front and the back measurement positions

Time Domain: Fig. 2 visualizes the results from two different array positions. The loudest sound sources were located at the ceiling above the chosen measurement position, 85.22 dB (front) and 83.06 (back) dB. In both scenarios, ground-reflected sources, around 68 dB, can also be seen.

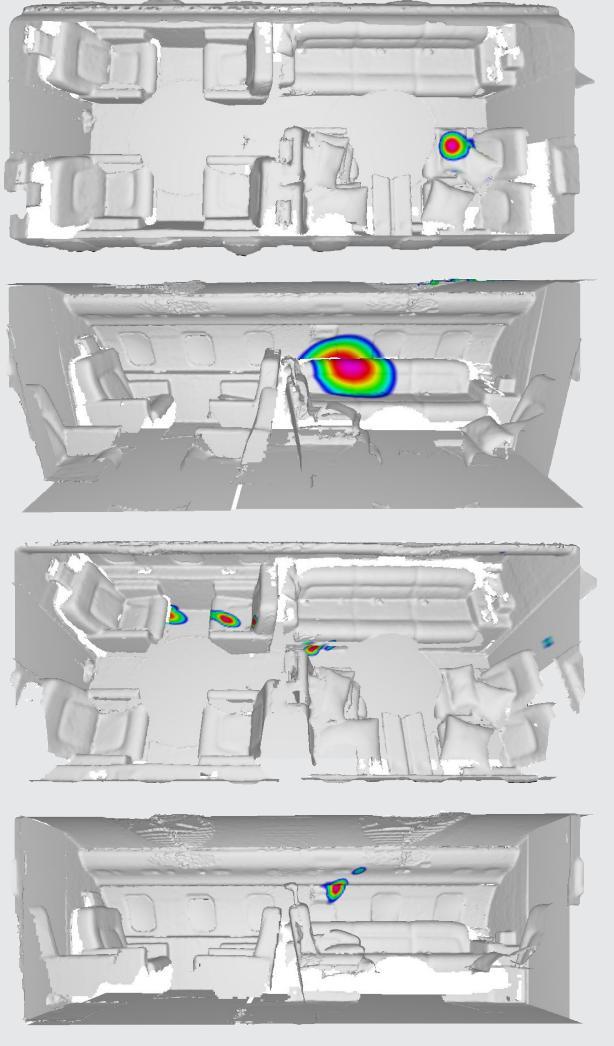
Fig. 1 From top to bottom respectively: Spectral analysis for the third octave bands of 250 Hz at 59.17 dBA, 315 Hz at 53 dBA, 3150 Hz at 22 dBA and 6300 Hz at 15.67 dBA measured from the back of the cabin

Frequency Domain: The origin of the noise was found in three different third octave bands of 250 Hz, 315 Hz, 3150 Hz and 6300 Hz. The sound was radiating from the floor in the middle of the cabin and from the side of the fuselage (see Fig. 1).
