APPLICATION NOTE

2D Outdoor Measurement THE ACOUSTIC CAMERA AS A TOOL FOR SOUND SOURCE LOCALIZATION

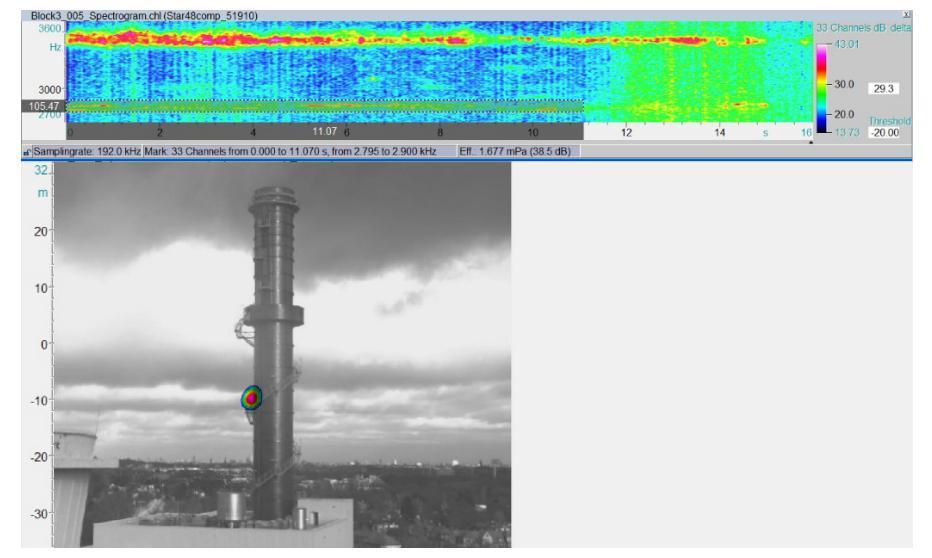
During the first measurement with the Star Array in the far field, the surrounding staircase at the chimney can be clearly identified as the main noise source (see Fig. 1). The sound spectrum shows discrete frequencies indicate a whistling of the wind over the grating structure. Using the Acoustic Camera, it was possible to associate these frequencies with different sound sources at the grating structure of the staircase (Fig. 2 left).

Fig. 1 Result of the overview measurement

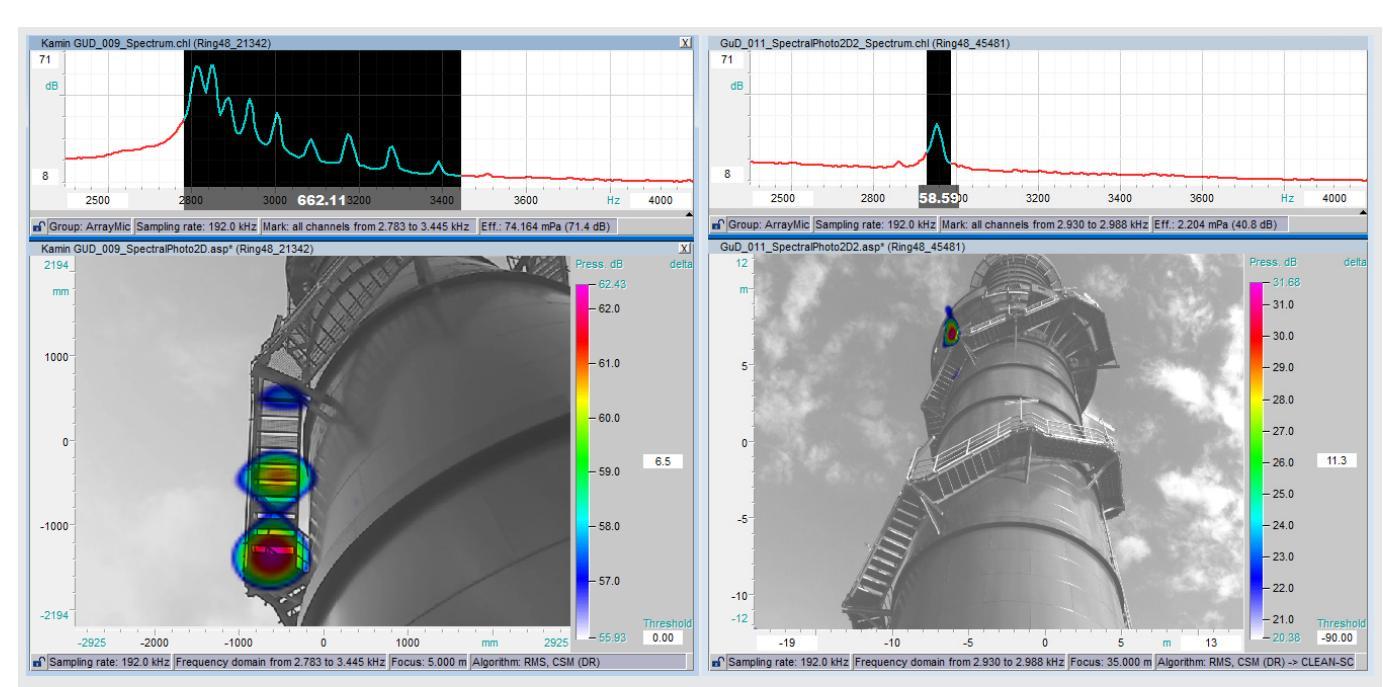
Another follow-up measurement shows the success of this measure. Only one sound source in the upper part of the chimney can be found (Fig. 2 right). This remaining sound source comes from the upper staircase, which the customer deemed irrelevant for the acoustic measurements so far. Subsequently, the flow acoustics were also improved here by installing additional rubber mats.

Fig. 2 Before and after comparison. *Left:* before acoustic optimization, *right:* after acoustic optimization.

In order to prevent this flow noise, the customer outfitted the stairs with rubber mats.
