Diagnosis in a Breath Non-destructive measurements for determining the performance of a CMUT ultrasound transducer

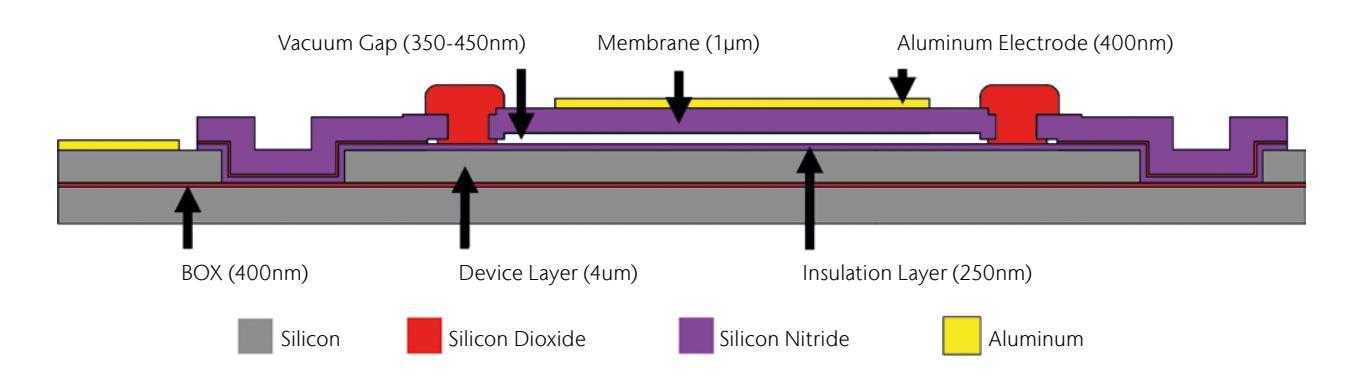
Figure 1: Cross-section schematic of a sacrificially released CMUT cell

Our CMUT cells are fabricated using two layers of sacrificial poly-silicon patterned to form the vacuum gap. The membranes are deposited on top of the sacrificial layers and are composed of a low-stress silicon nitride film that is released using a heated potassium hydroxide solution to dissolve the poly-silicon films. Subsequently, the volume formally occupied by the sacrificial layers is sealed under vacuum using silicon dioxide plugs. A cross-section of an individual CMUT membrane is shown in Figure 1. In order to operate the large number of CMUT cells required for a greater field-of-view, our CMUT

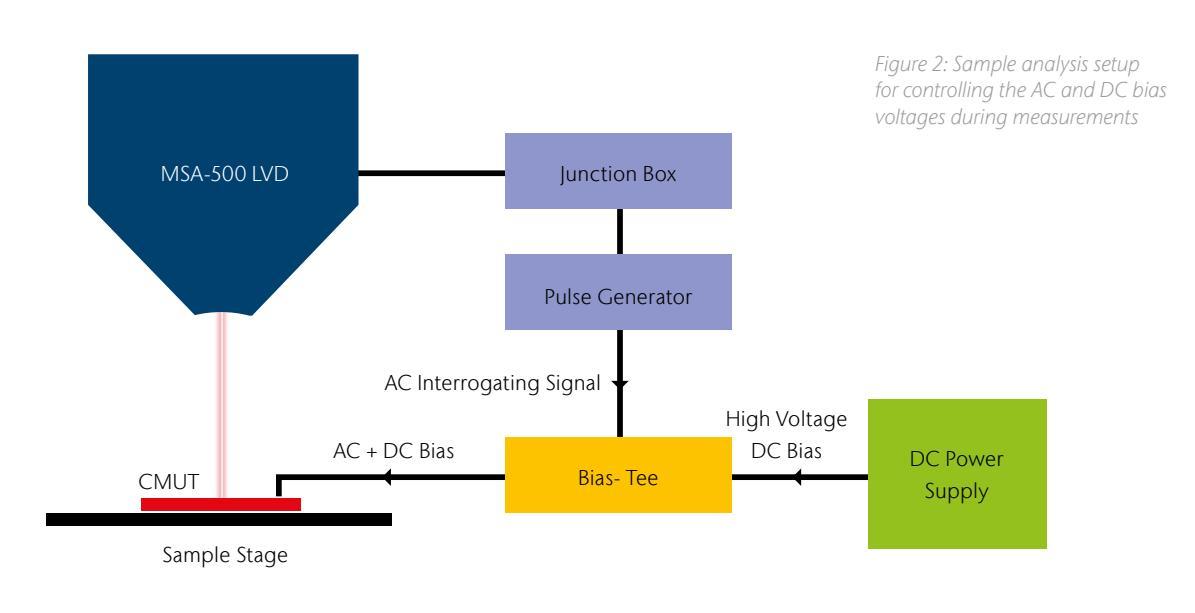
For our characterization measurements, we utilize Polytec's MSA-500 Micro System Analyzer Laser Doppler Vibrometer. Each CMUT array is mounted on a sample stage and connected using three-axis micropositioning probes. Each array is driven using a combined AC and DC bias voltage connected using a bias-tee as shown in Figure 2. When evaluating the performance of a sensor array, we focus on measurements of the resonant frequency and dynamic displacements for different AC and DC driving conditions. We are interested in comparing results between different positions across the device, to analyze the general performance of the array, and

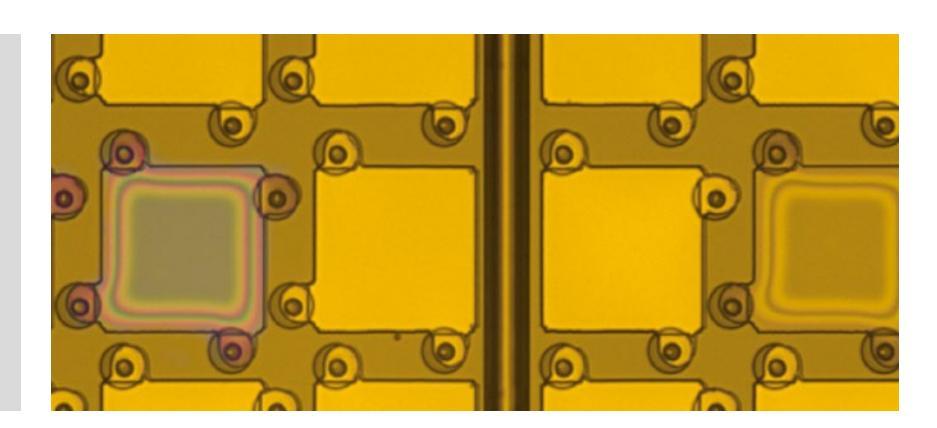
Figure 3: Two collapsed CMUT cells due to fabrication errors

When evaluating CMUT cells, it is critical that every membrane operates identically, otherwise small deviations across the array, or clusters of dead cells, will create artifacts while imaging with these sensors. Some of these variations can be spotted visually using a microscope, such as collapsed or deformed cells shown in Figure 3. > However, if the sealing plugs leak in any of the CMUTs, then the cavities will fill with air causing a shift in the resonant frequency and performance of the cell, while appearing through the microscope to be no different from a vacuum sealed membrane. This shift in resonant frequency, as well as a decrease in dynamic displacement, is caused by the damping effects of squeezing and stretching a pocket of air at the Megahertz frequencies used for medical imaging. These defects normally can only be observed when operating the sensor, so it is beneficial to probe the device and determine if these defects exist before spending

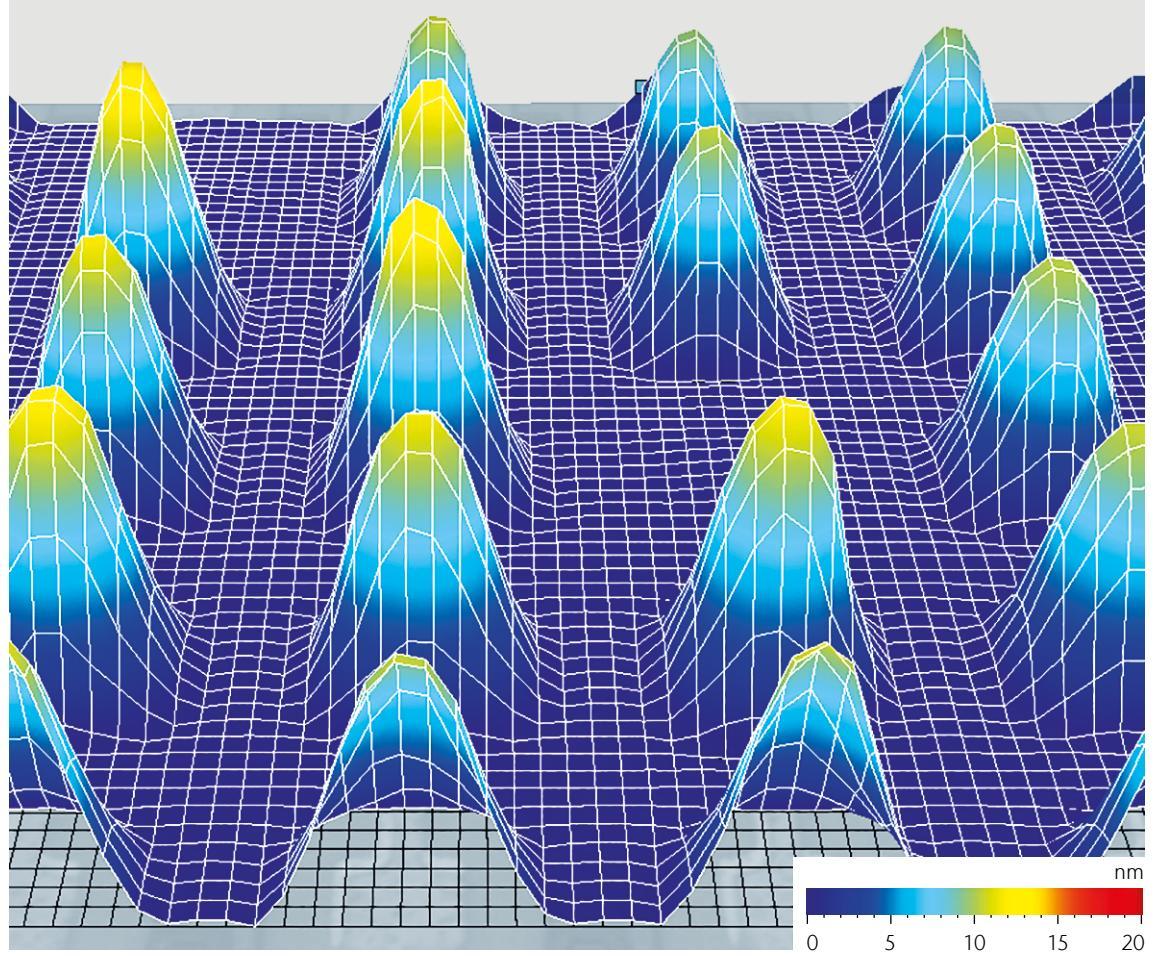
Figure 4a: Laser Doppler Vibrometer measurements of several leaking CMUT cells, visible with a much lower dynamic displacement when operating the device.

An example of several leaking membranes is shown in Figure 4a, where 2 cells are not resonating at the same frequency as the rest of the array when operating with sinewave excitation. We can further investigate the operating frequency of both the ideal CMUT cell and the defective sensor using a pseudorandom excitation signal with the vibrometer, as shown in Figure 4b. As you can see the air present in the membrane shifts the resonant frequency higher while also decreasing the dynamic displace ment for a given operating voltage.
