# Minimize Disturbances by Design

## Polytec Technical Papers

## Optimization of Air Flow in the Read/Write Unit of Hard Disk Drives Using Laser-Doppler Vibrometry

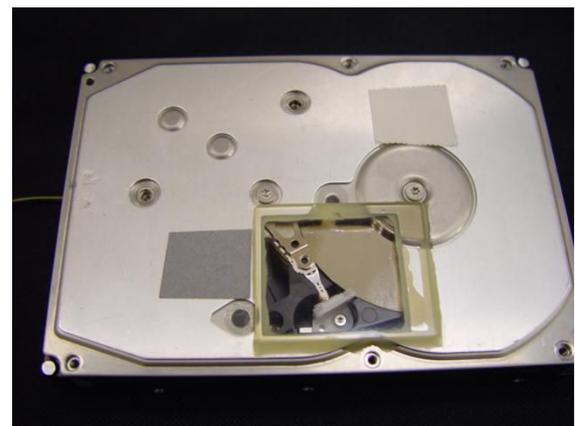
The front cover of the drive was modified with an optically clear glass plate shown in Figure 1 so a laser beam could be projected onto the top head in the drive.

Figure 1: Window in HDD cover.

The drive was placed in a LDV laser microscope system with a laser beam projected through the microscope's optics and then through the drive's front cover via the glass window. The signal was received back again by the reflected beam. A strong resonance signal band of low frequencies was discovered on the trailing edge of the slider with the laser beam reflecting through the suspension and focused onto one of the two trailing edge corners of the head shown in Figure 2.
