3D Interior Measurement

THE ACOUSTIC CAMERA AS AN EFFECTIVE TOOL FOR THE NVH ANALYSIS OF VEHICLES

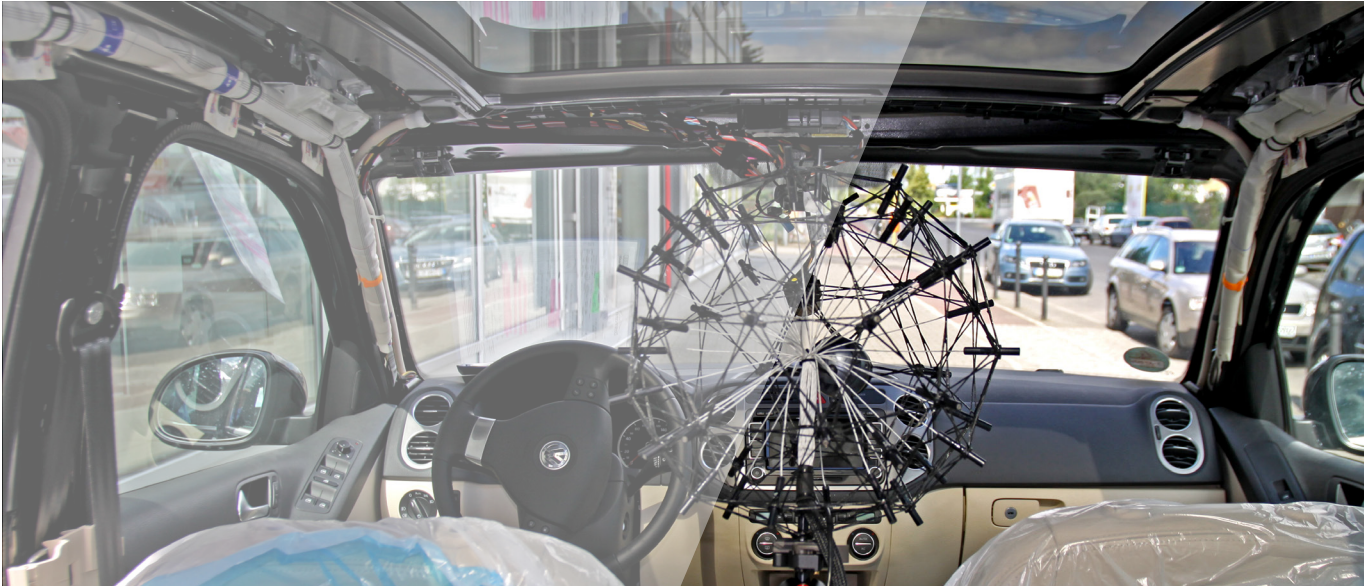
For the measurement, the Microphone Array and the Data Recorder were positioned inside the cabin of each car. The mobile power supply was set up in the trunk of the car. All measurements were conducted while driving on the road to capture real-life conditions. Afterwards, CAD models of the vehicles were integrated into the channel data and each cabin was analyzed three-dimensionally.
